**Laurel Fringe Lot  
Commuter Parking  
(LFL)**

**UPPER PATUXENT RIVER WATERSHED RESTORATION ACTION STRATEGY (WRAS)  
FORM 1 -- Catchment Information**

## UPPER PATUXENT RIVER WATERSHED RESTORATION ACTION STRATEGY (WRAS) FORM 2 -- Site Information

Site Name: Laurel Fringe Lot Address: Laurel Bowie Road  
 Site Owner: Prince George's County Parking Division  
 State Plane Coordinates of Site Centroid: X: 1355843 Y: 514252 Date: 3/25/03  
 Personnel: PM Weather: sunny, 70F deg  
 Area (ac): 8.4 Impervious Area (ac): 5.5  
 Percent Impervious: 65% Soil Recharge Factor (S): 0.13  
 WQ<sub>v</sub> (required): 0.63 Re<sub>v</sub> (required): 0.08  
 Property Area (ac): 10 Property Area Included in Site: 84 %  
 Amount of Catchment Occupied by Site: 50 %

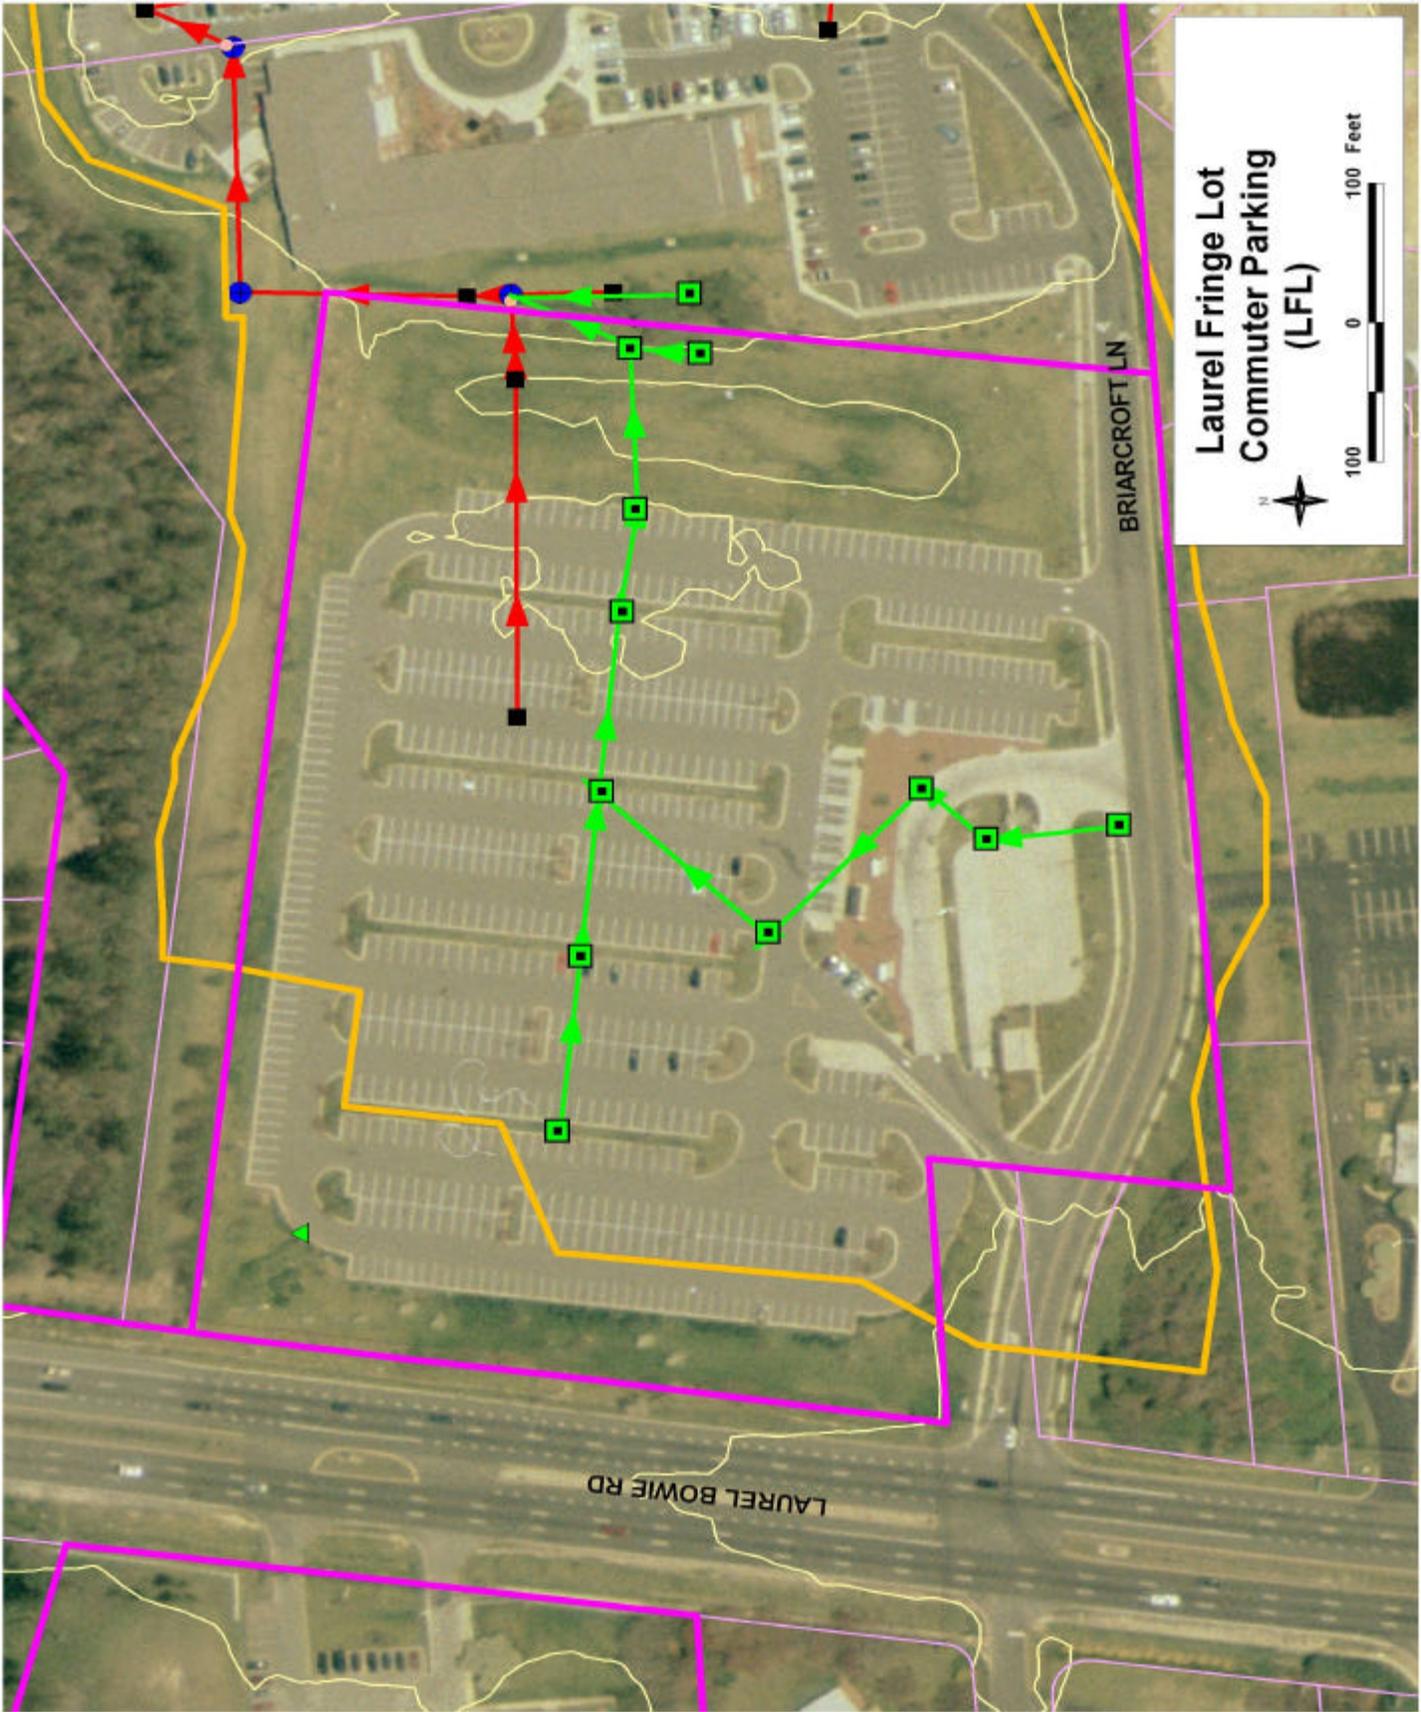
Outfall SDI ID or Outfall Description: SDI 54229 (outfalls to SWM pond)

Drainage Area (ac): 16.9 Impervious Area (ac): 10.0

Percent Impervious: 59% Soil Recharge Factor (S): 0.13

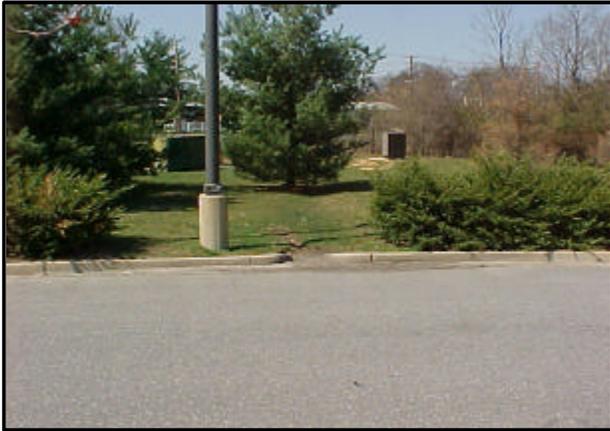
- No. 427 Description: looking northwest at curb cut (potential treatment)
- No. 428 Description: looking east at north side of lot
- No. 429 Description: looking southeast across lot
- No. 430 Description: looking south at west side of lot
- No. 431 Description: looking east at south side of lot
- No. 432 Description: looking northeast across lot
- No. 433 Description: looking west across lot
- No. \_\_\_\_\_ Description: \_\_\_\_\_
- No. \_\_\_\_\_ Description: \_\_\_\_\_
- No. \_\_\_\_\_ Description: \_\_\_\_\_
